BRIDGE CONDITION REPORT

ROUTE: FAP 627 (IL 71)

EXIST. S.N.: 050-0030

**LOCATION: ILLINOIS ROUTE 71
OVER STREAM**

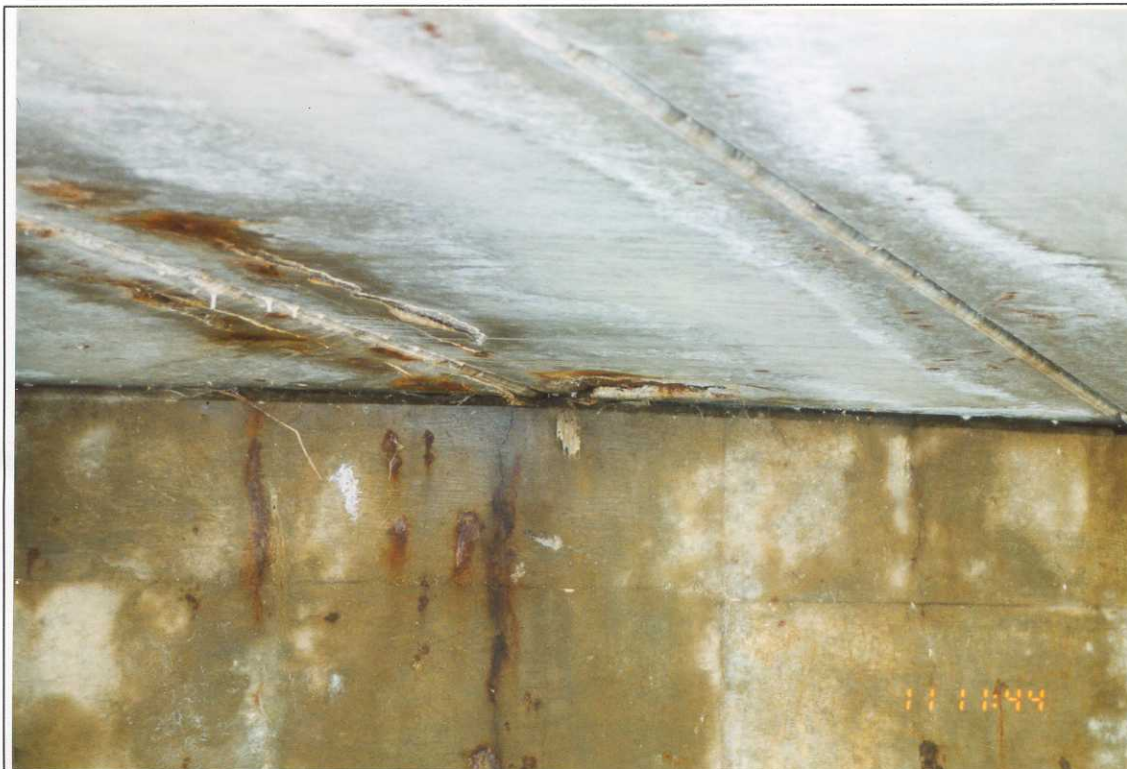
43) Spalling at West Abutment 6<sup>th</sup> Beam From North, Span 1

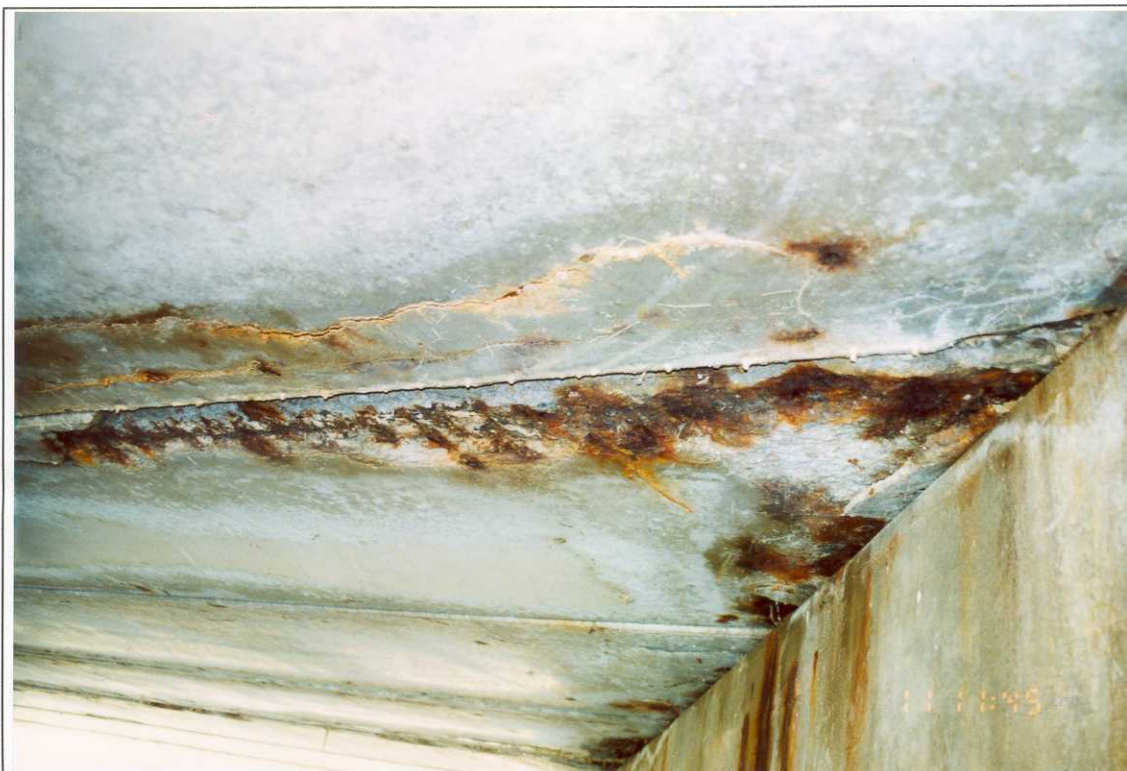
44) Spalling and Delaminations Near Pier, 6<sup>th</sup> and 7<sup>th</sup> Beams From the South, Span 1

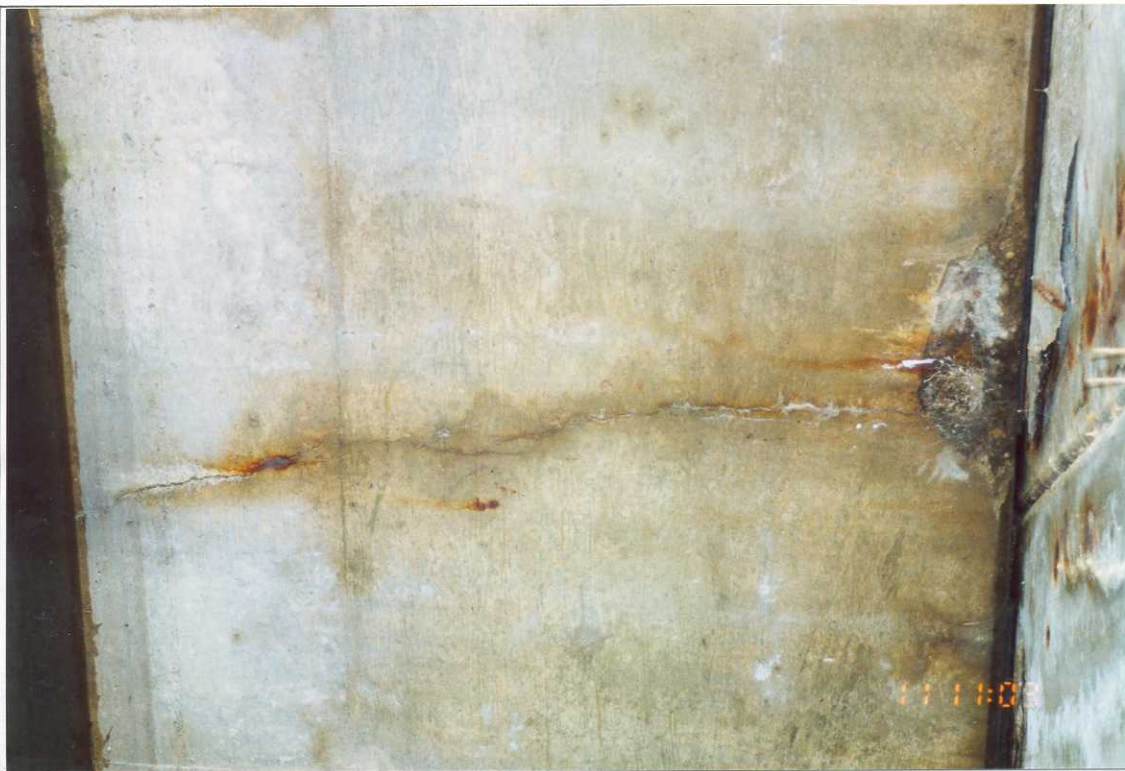
48) Spall at Top West Face of Pier, Crack at Joint of 3<sup>rd</sup> and 4<sup>th</sup> Beams From South

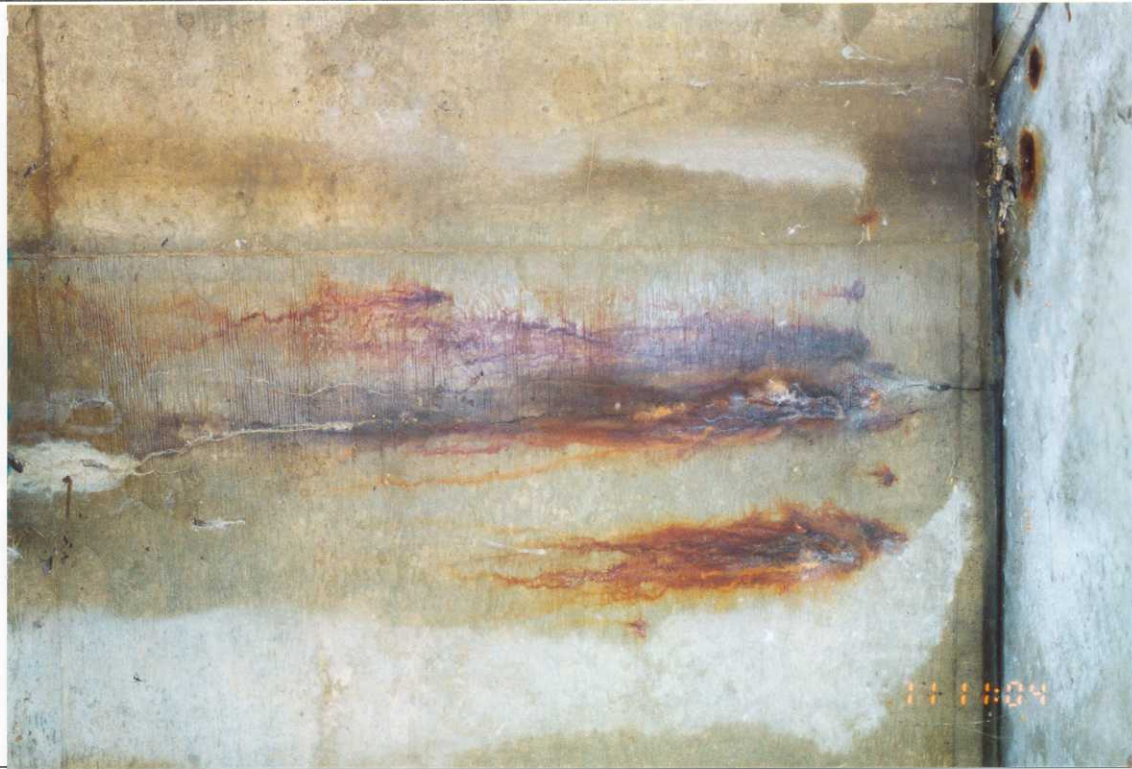
49) 1/8 Crack with Rust and Leaching Under 6<sup>th</sup> Beam From South, West Face of Pier

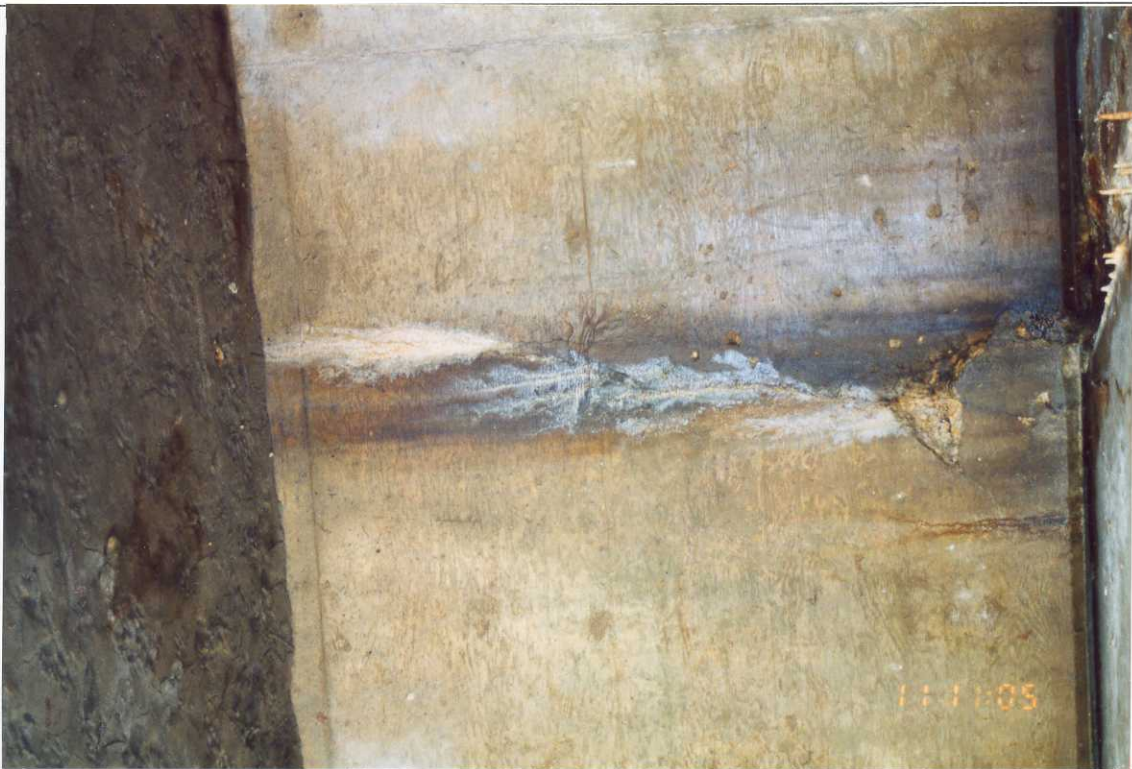
50) Crack with Leaching, West Face of Pier at Joint of 3<sup>rd</sup> and 4<sup>th</sup> Beams From North

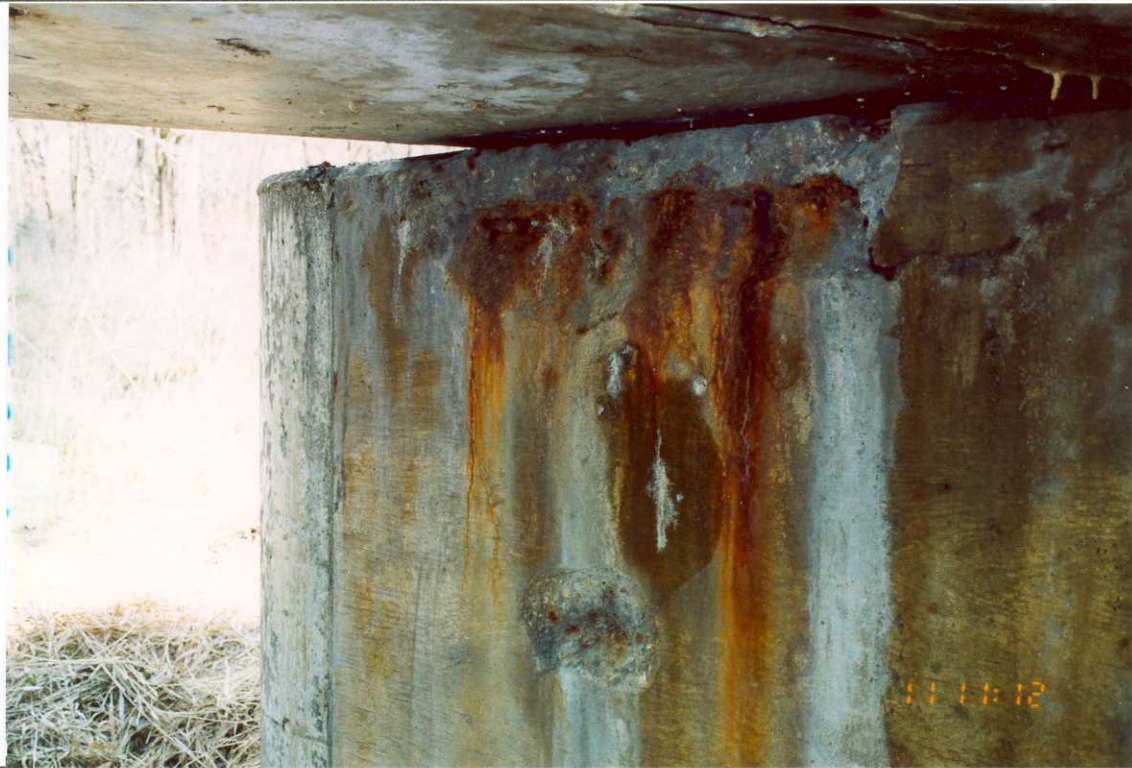
53) Spalling Under 1<sup>st</sup> Beam From North, East Face of Pier

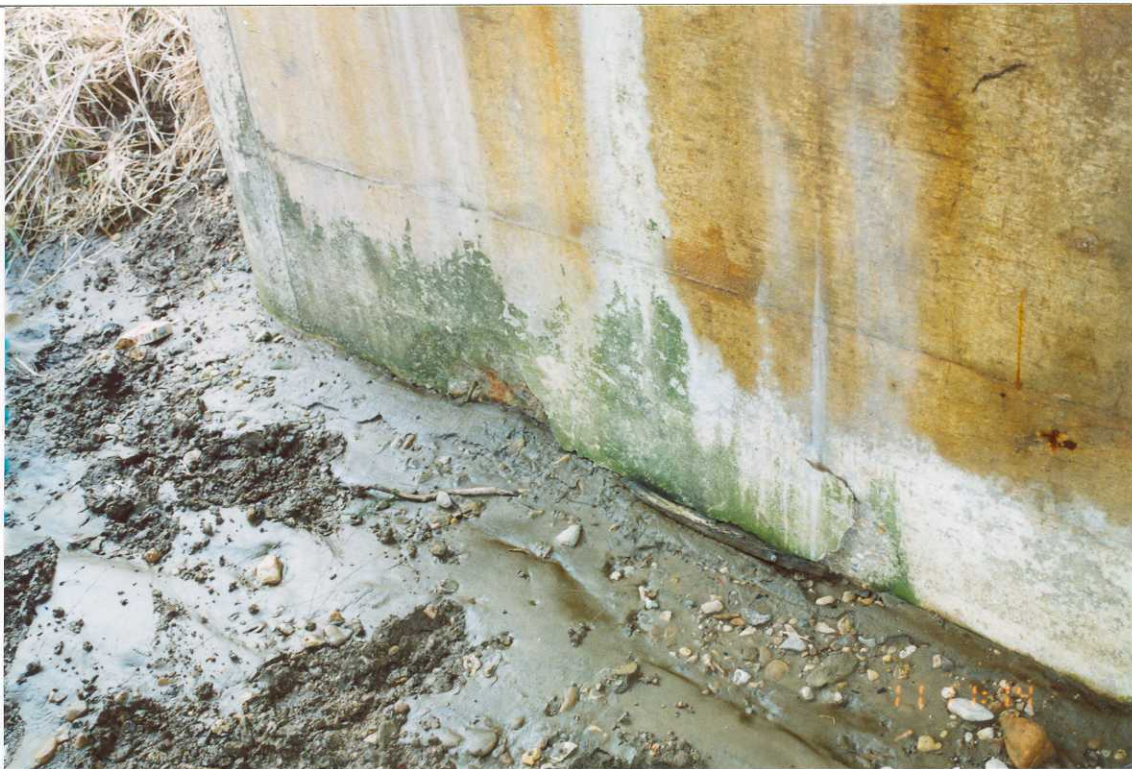
54) Spalling at Ground Line, North End, East Face of Pier

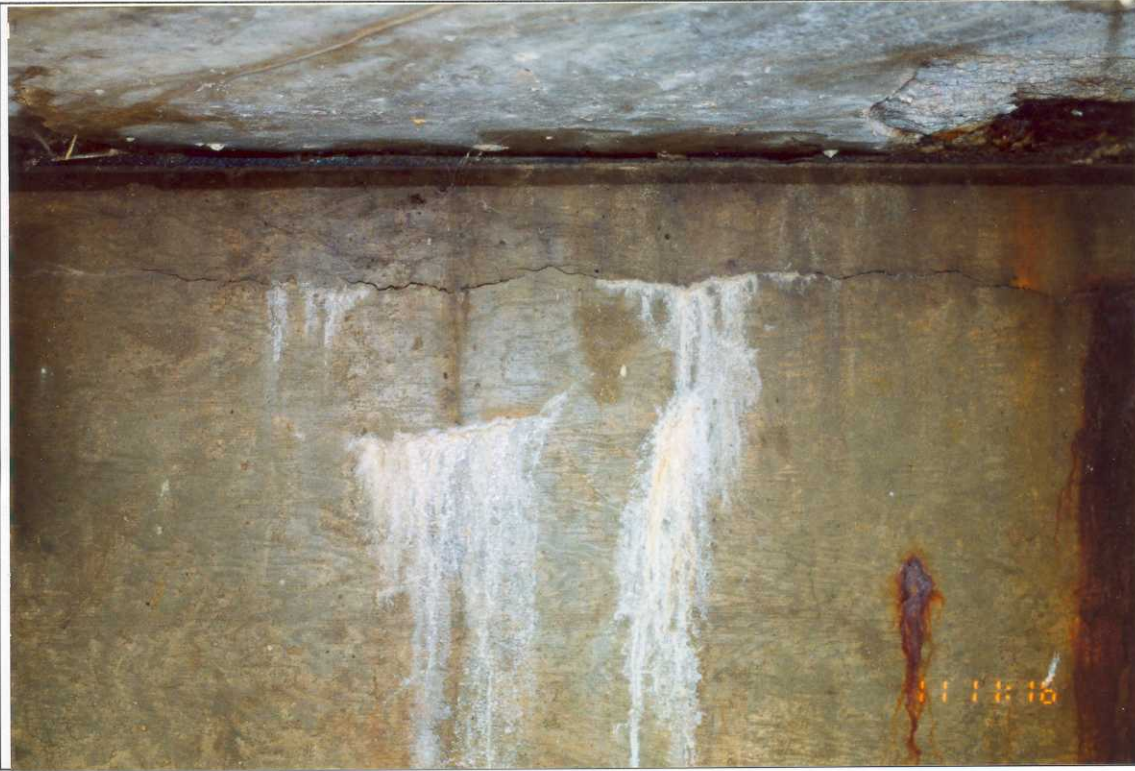
Note Moisture.

55) Horizontal Cracks at Top of East Face Below 3<sup>rd</sup> Beam From North

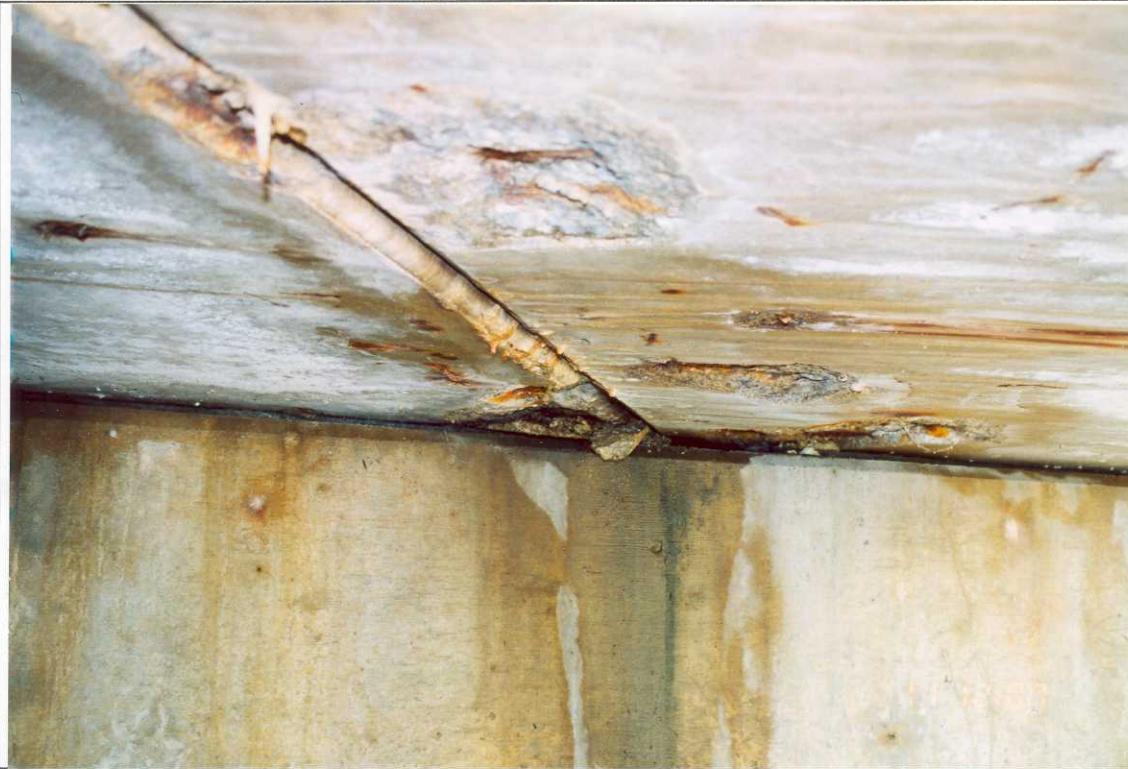
57) Spalling at Pier 1<sup>st</sup> and 2<sup>nd</sup> Beams From North, Span 2

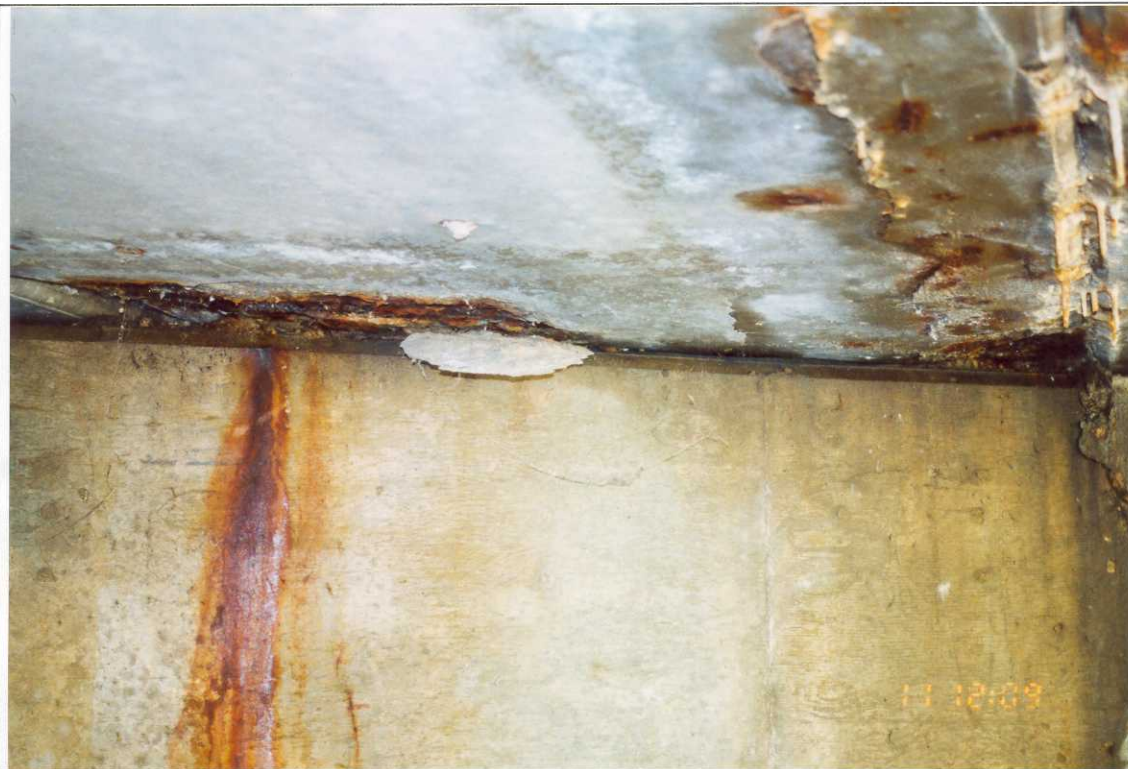
58) Spalling at Pier 4<sup>th</sup> Beam from North, Span 2

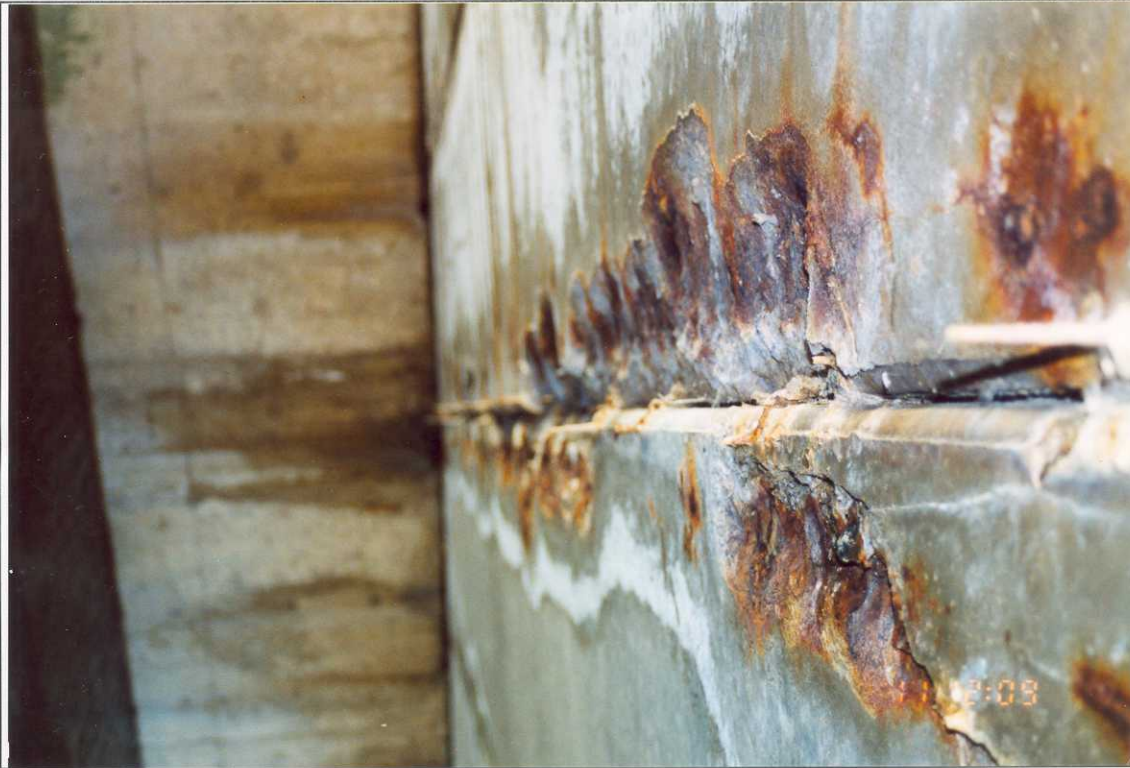
59) Spalling Along 3<sup>rd</sup> Joint From North, Span 2

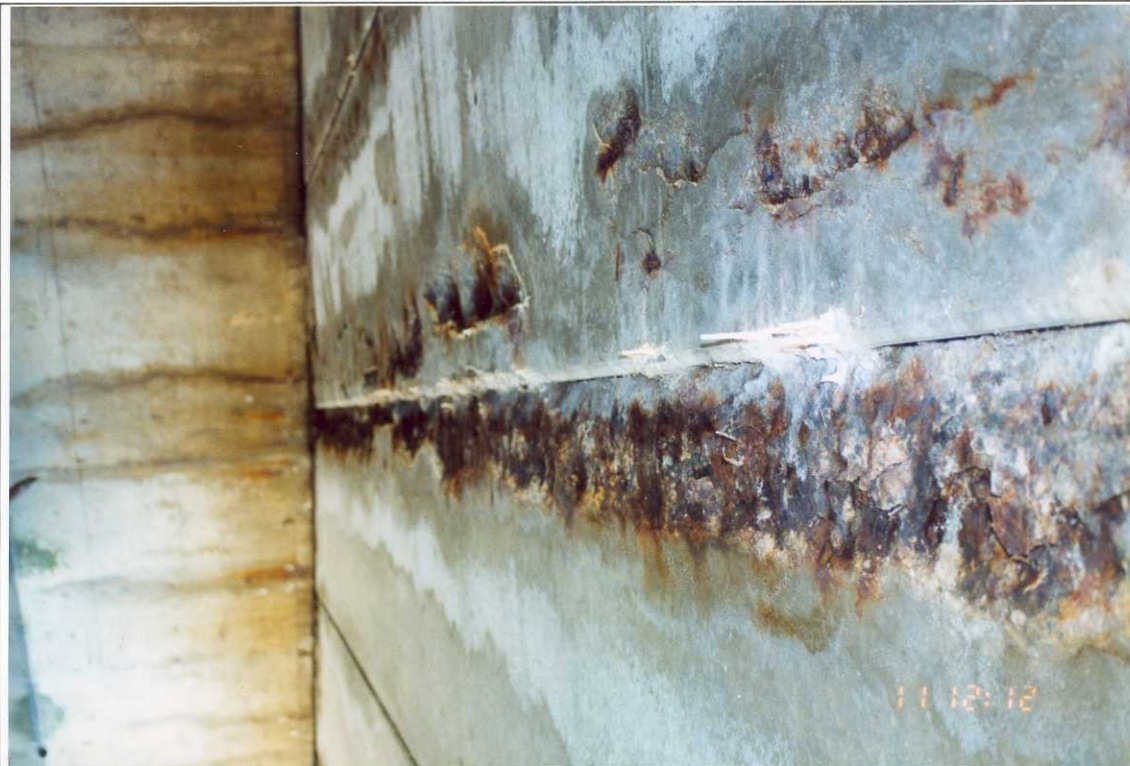
60) Spalling Along 6<sup>th</sup> Joint From North (Looking East) Span 2

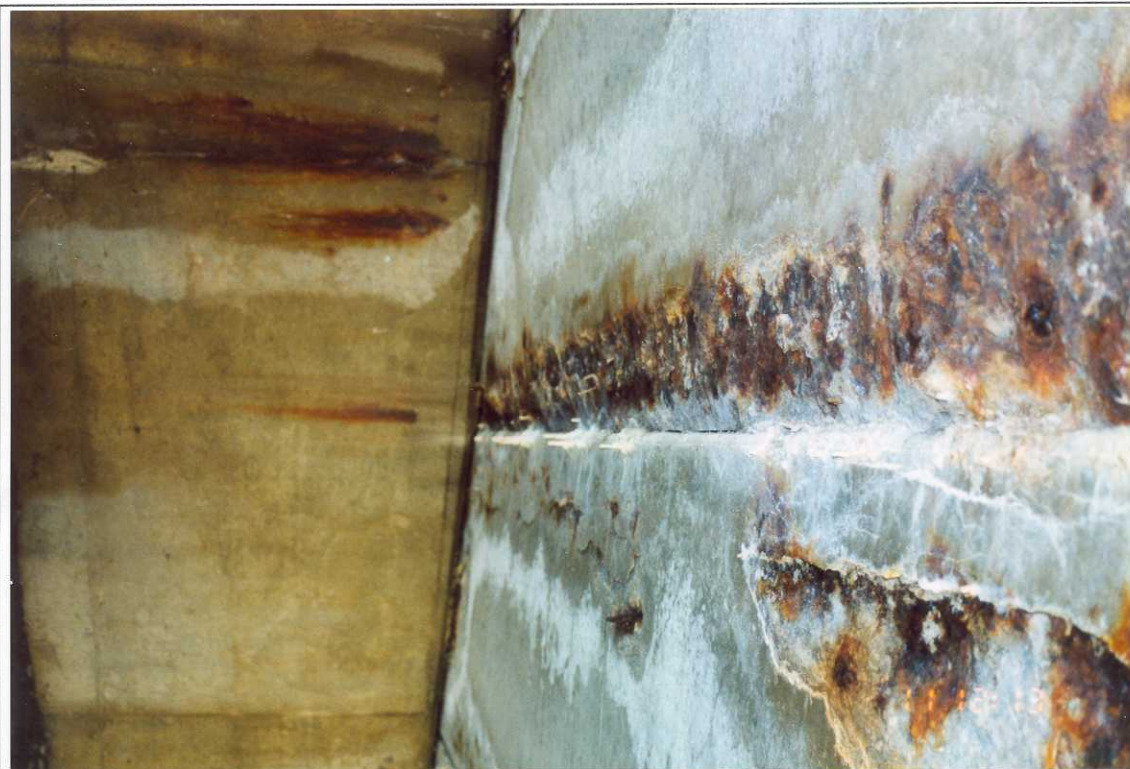
61) Spalling Along 6<sup>th</sup> Joint From North (Looking West) Span 2

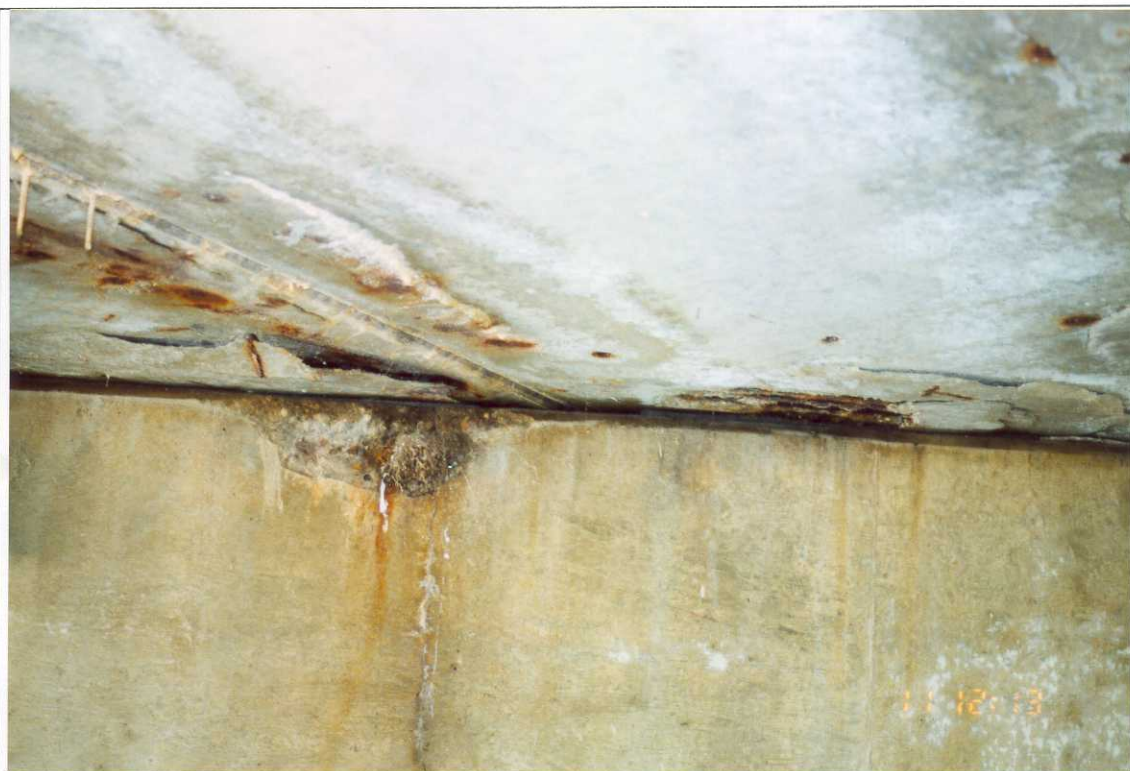
62) Spalling at Pier of 4<sup>th</sup> and 5<sup>th</sup> Beams From South, Span 2

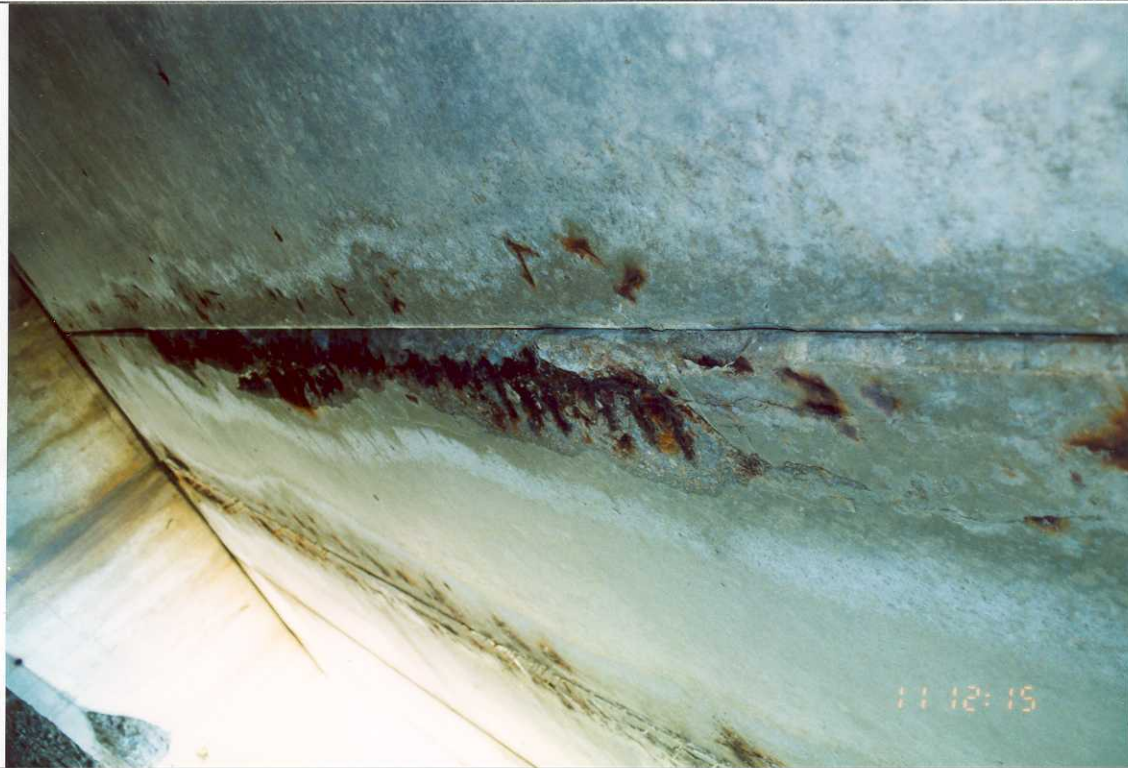
63) Spalling and Cracking Along 4<sup>th</sup> Joint From South, Span 2

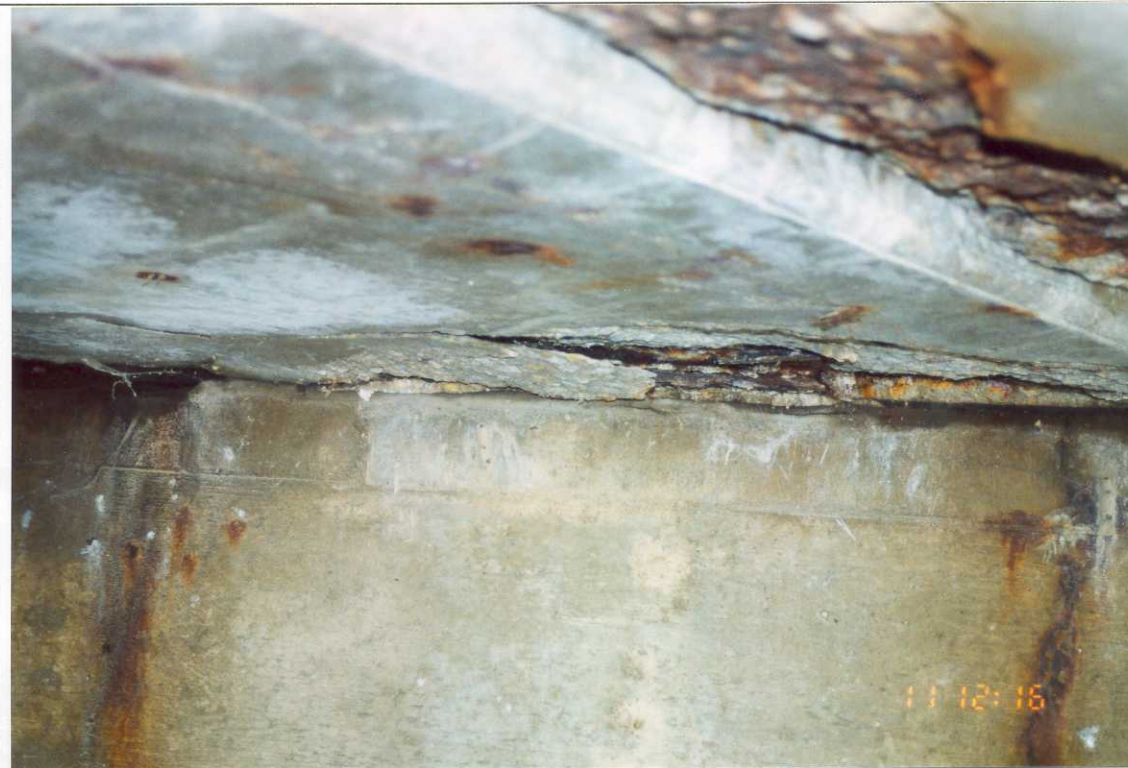
64) Spalling at Abutment 7<sup>th</sup> Beam From South, Span 2

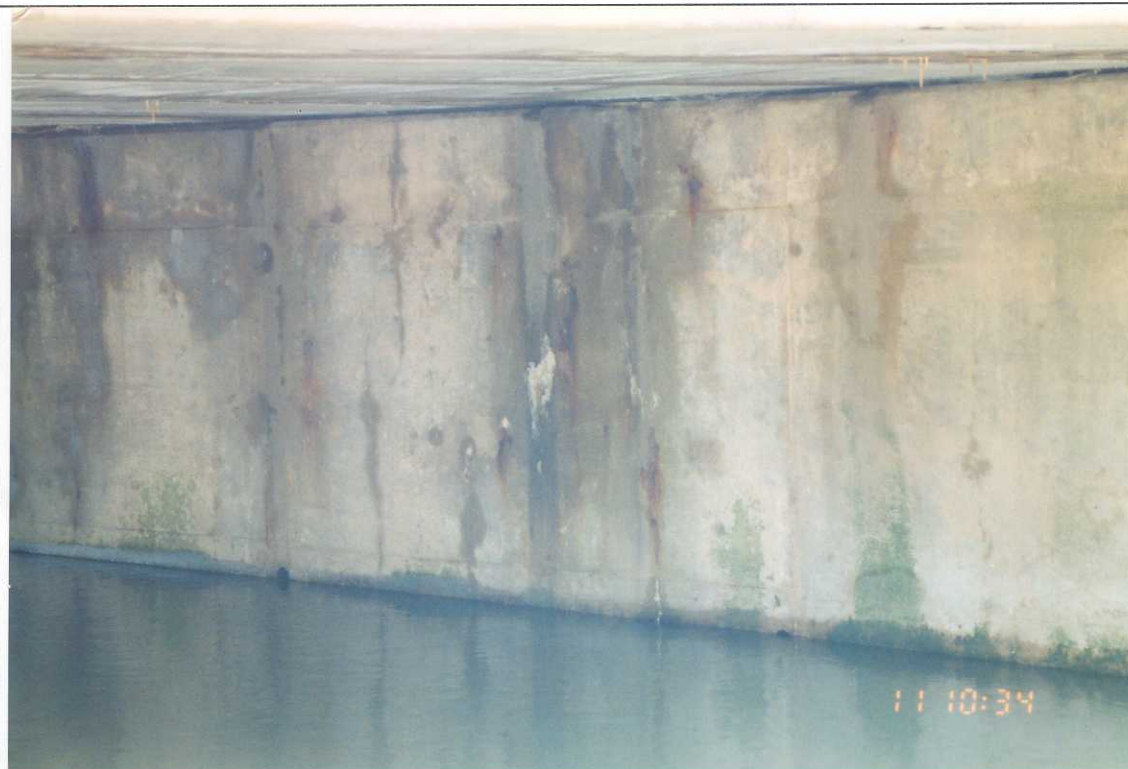
65) Typical Moisture Staining and Cracking of West Abutment

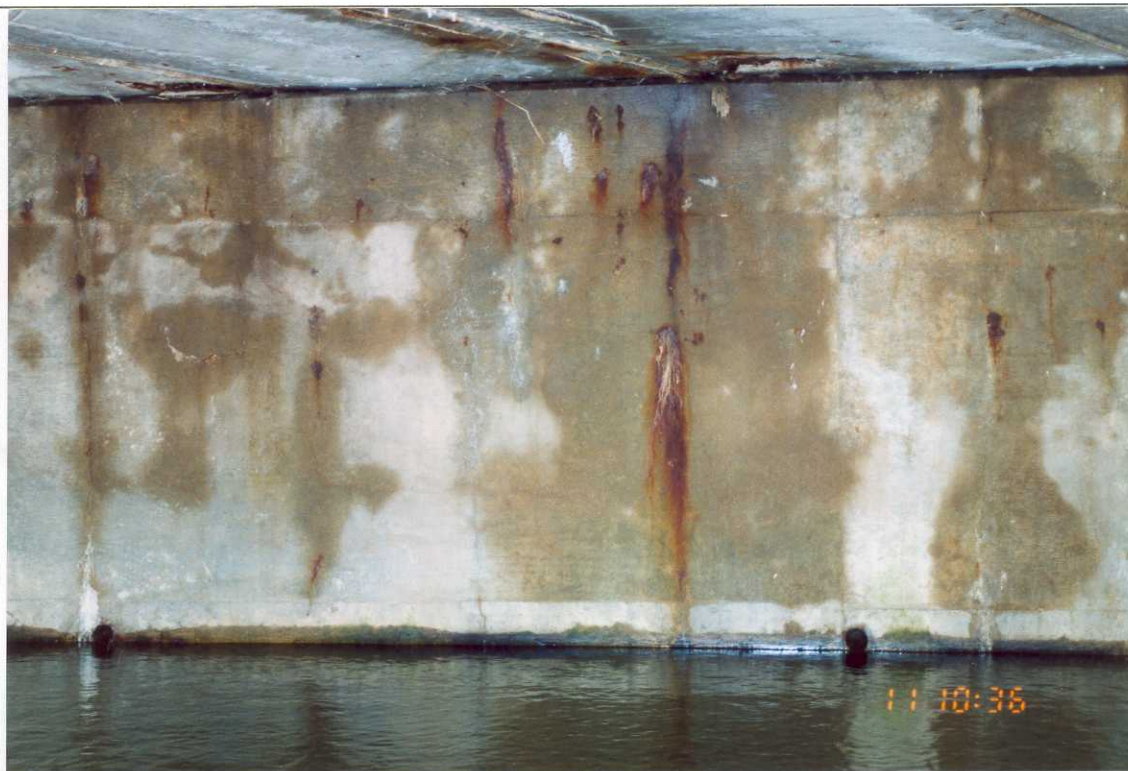
66) Showing Typical Moisture Staining and Cracking of West Abutment

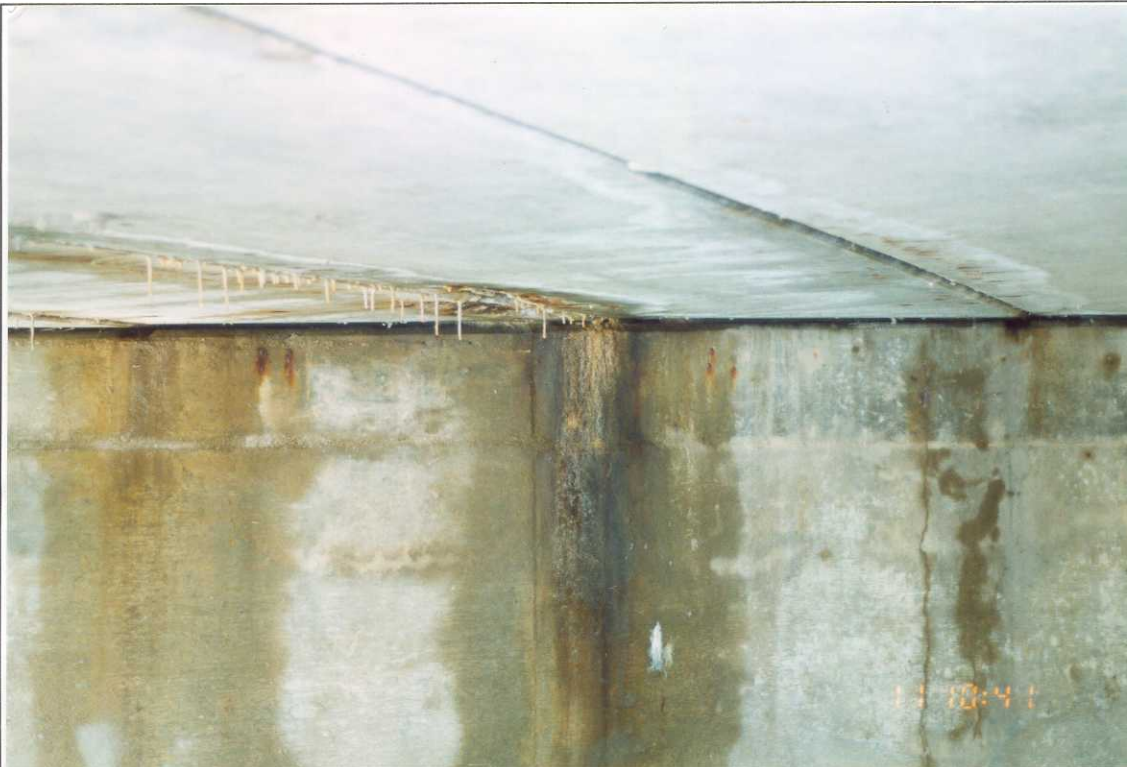
70) Show Typical Moisture Staining at Abutment

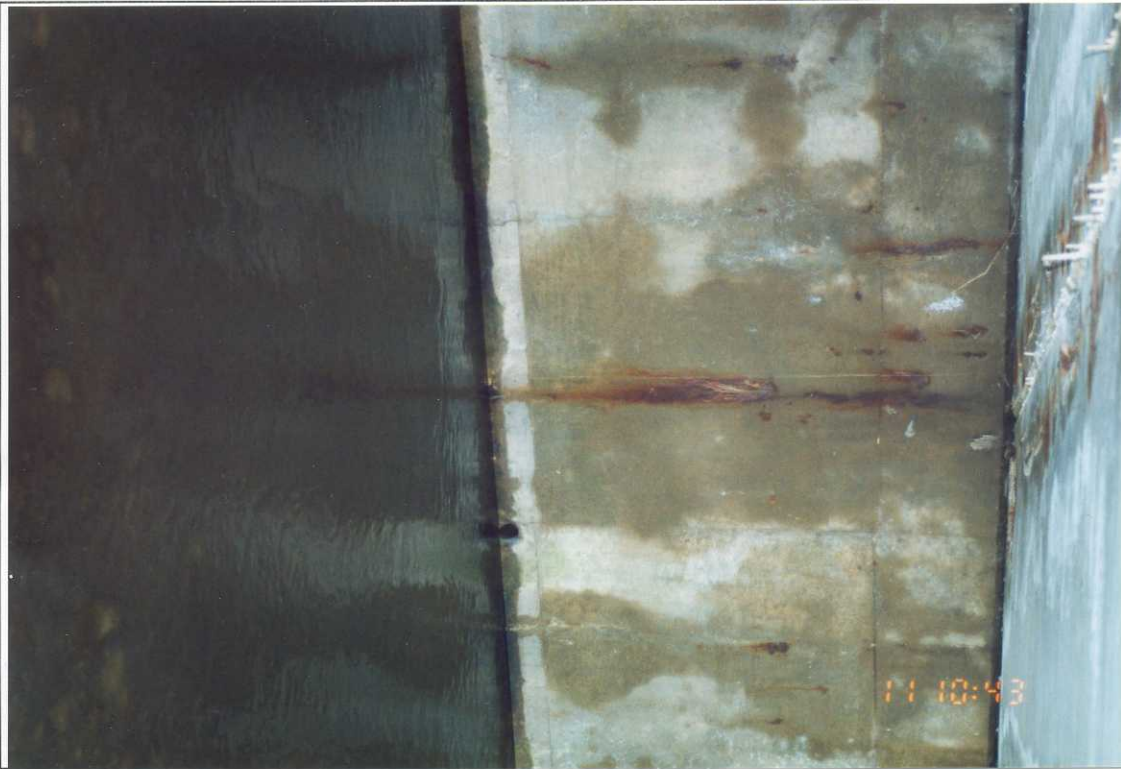
71) Show Typical Moisture Staining at Abutment
